Manhole Inspection Summary

Manhole # S13CC_024MH

Location Address: **1104 DUKELAND ST**

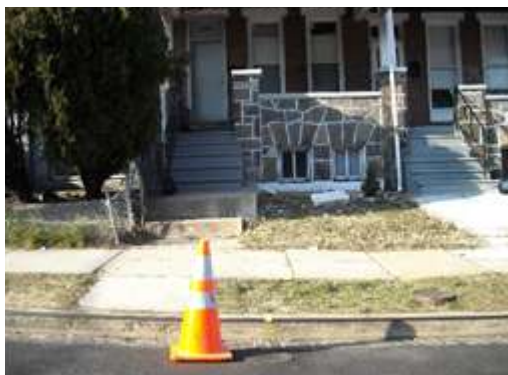
Location View

Cannot Access - Buried - Manhole Existing Confirmed by As-built

Comments **BELIEVE IT IS A GAS FEATURE IN THE STREET**
